Orlando, Florida
April 24-27, 2005

LABORATORY EXAMINATION OF A CURED IN PLACE PRESSURE PIPE LINER FOR POTABLE WATER DISTRIBUTION SYSTEM

Erez N. Allouche¹, Kevin Bainbridge², and Ian D. Moore³

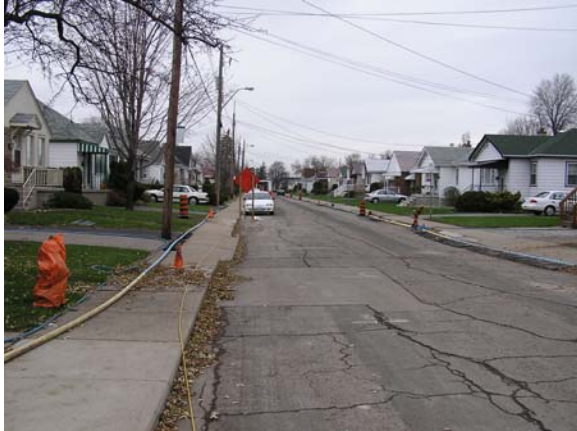
Figure 2. Field site, Hamilton City.

In the fall of 2003 a 1000m long section of a 75 year old 150mm cast iron watermain along West 2nd street, which exhibited approximately 2.5 breaks per kilometer per year in recent years, was lined with an Aqua Pipe™ by one of Sanexen's licensed installers in Ontario, Fer-Pal Construction Ltd. The site location and pipe segments selected for this pilot project were identified by the City to have characteristics similar to a large number of pipes in the network exhibiting similar failure rates

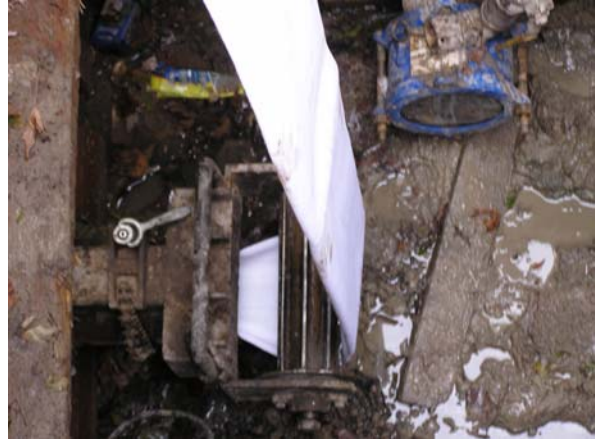
Figure 3. Resin impregnated liner pulled into place.

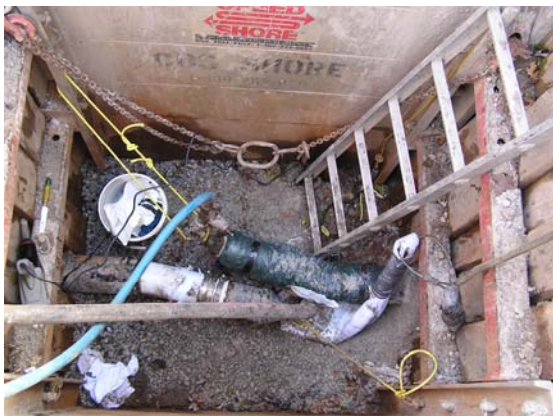
Figure 4. Liner inflation and curing using hot water

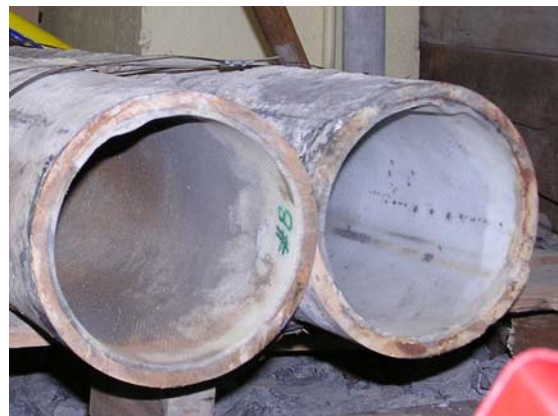
Figure 5. Exhumed liner samples.

The operational water pressure in this part of the city is 350 - 420 kPa with periodical surges of 560 to 770 kPa, which are believed to last 10-12 seconds. Following the installation, excavations were performed by Fer-Pal Construction at a number of locations along the alignment, and short sections (~1.2m long) of the lined cast-iron watermain were exhumed for testing and evaluation purposes. A total of twelve samples were recovered, representing a wide range of conditions and configurations including straight sections, sections with stainless repair clamps, a section with a bell-and-spigot joint, a section with a water hydrant and a section with tap connections. Images of the field site (Figure 2), pulling the collapsed liner into place (Figure 3), liner inflation and curing using hot water (Figure 4), and exhumed samples supplied for testing (Figure 5) are provided here to briefly characterize the rehabilitation project.

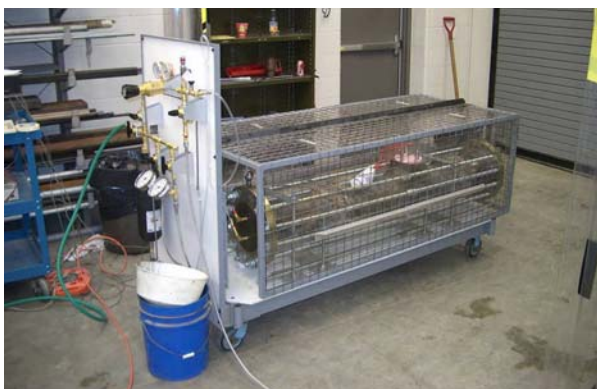
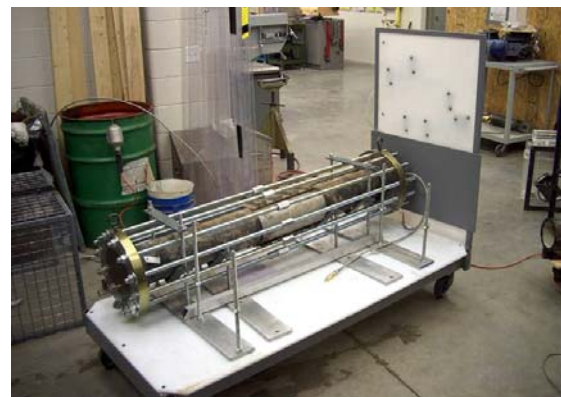
The internal pressure testing program included seven burst tests and one long-term pressure test. All tests were conducted using a custom-made pressure cell fabricated at the University of Western Ontario. The device was designed specifically for this test program, with emphasis on protection measures to ensure the safety of the operator. The testing apparatus can generate in a pipe specimen filled with water an internal pressure of up to 5 MPa. The internal pressure is read via an external gauge accurate to ± 35 kPa (see Figure 6).

Figure 6. Custom-made pressure cell - 12 equality-space high-strength threaded rods are used to apply a compressive force to the ends of the specimen.

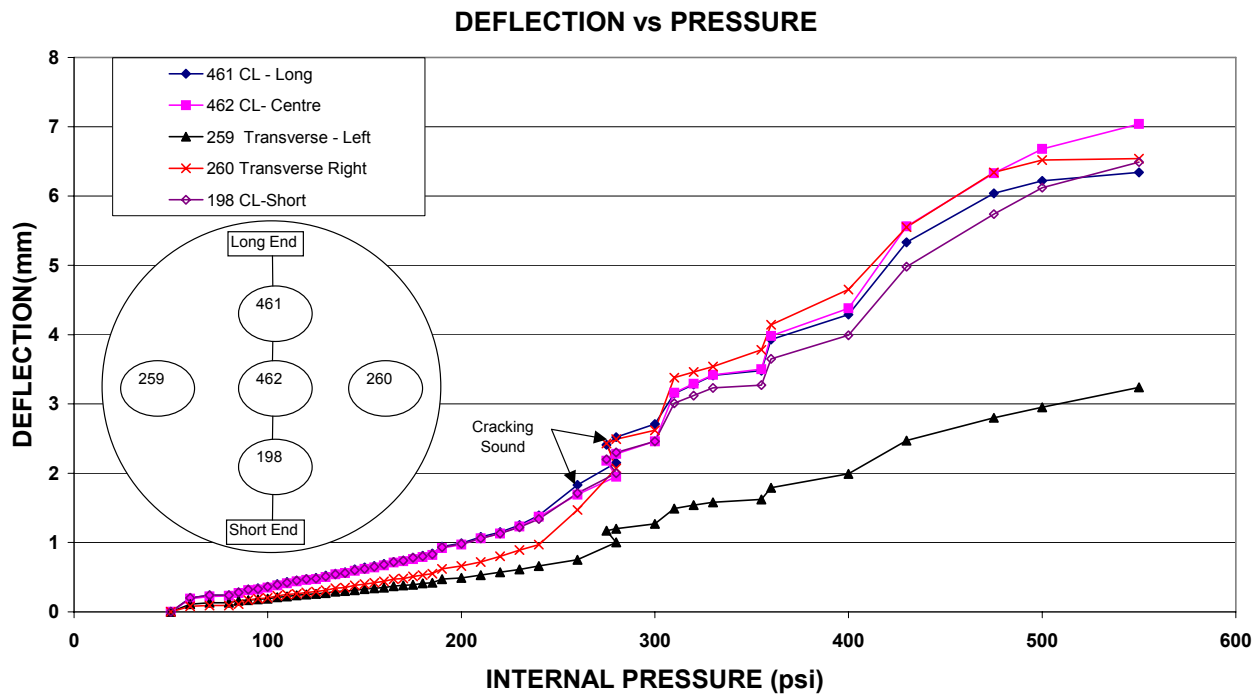
Figure 9. Deflection vs. internal pressure as measured by the LVDTs instrumentation for Burst Test #2

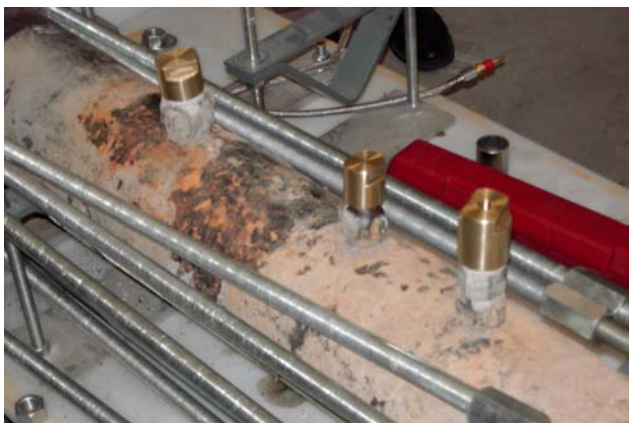
A straight section with three tap connections spaced approximately 150mm apart (Figure 14). Brass caps were custom-fabricated to seal the three tap connections and the specimen pressurized to 2.1 MPa in 350 kPa increments, with the pressure held at each pressure increment for a minimum of 5 minutes. The pressure level of 2.1 MPa was maintained for 135 minutes, in an attempt to cause damage to the liner-tap connection interface. At the end of this time period the pipe segment was de-pressurized and cut transversely at the centerline of each of the tap connection, enabling examination of the cross-section of the liner-tap connection interface.

Figure 14. Specimen # 3 prior to testing

The liner-connection interface inspection revealed a gap between the liner and the pipe wall where the tap connection protrudes into the cast iron pipe. While most of this space was filled with a plug and resin, a small air pocket was also observed.

Another observation was that the cutter did not restore the tapped connection to its original diameter, leaving a liner rim of 1/16" to 1/8" in thickness around the tap connection circumference. Depending on the diameter of the tap connection, the presence of the rim represents a 10-15% reduction on the tap cross-sectional area. A potential solution is to send, following the cutter, a grinding tool that will restore the original diameter of the tap connection.
