NANCY AMPIAH, MSC (2008)

RESEARCH SUMMARY

SAMPLES USED FROM A CAST IRON PIPE REPAIR PROJECT IN HAMILTON

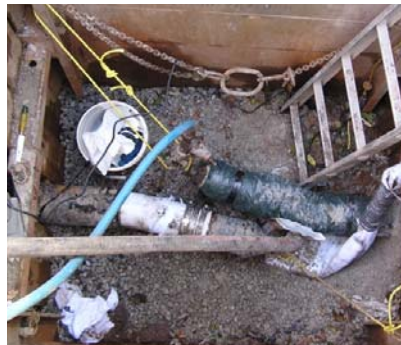
Small access pits are excavated at either end of the cast iron water pipe to be repaired. A resin-impregnated tube is then pulled into place within the cast iron pipe. Hot water is used to cure the composite liner. However, variable inner circumference in the cast iron pipe leads to excessive liner circumference, and the liner wrinkles as it is pushed by the hot water out against the inner wall of the old pipe.

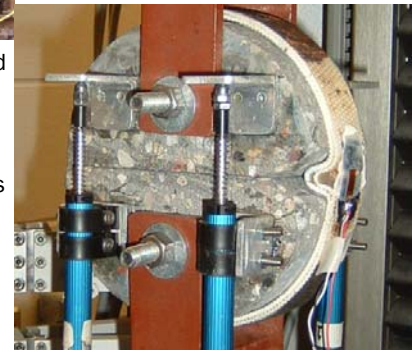
The split disk test procedure from ASTM D2290 used to investigate strength of the wrinkled liner.

A review of the system for Hamilton City in 2004 revealed that wrinkles can form in these composite liners. Nancy Ampiah developed procedures to test the strength of wrinkled liner specimens cut from samples exhumed after the field trial in Hamilton. Resin fracture occurs first, and leads to reductions in hoop stiffness of the composite liner. These fractures invariably occur in the vicinity of the wrinkle. Loading rate had no effect on cracking load for the liner, but sustained load reduces the ultimate strength of the liner system. All liners tested had strength sufficient to resist the design loads.
