GCL Shrinkage and the potential benefits of heat-tacked GCL seams

R.K. Rowe, GeoEngineering Centre at Queen's-RMC, Department of Civil Engineering, Queen's University, Kingston, ON, Canada

R. Thiel, Vector Engineering, Grass Valley, CA, USA

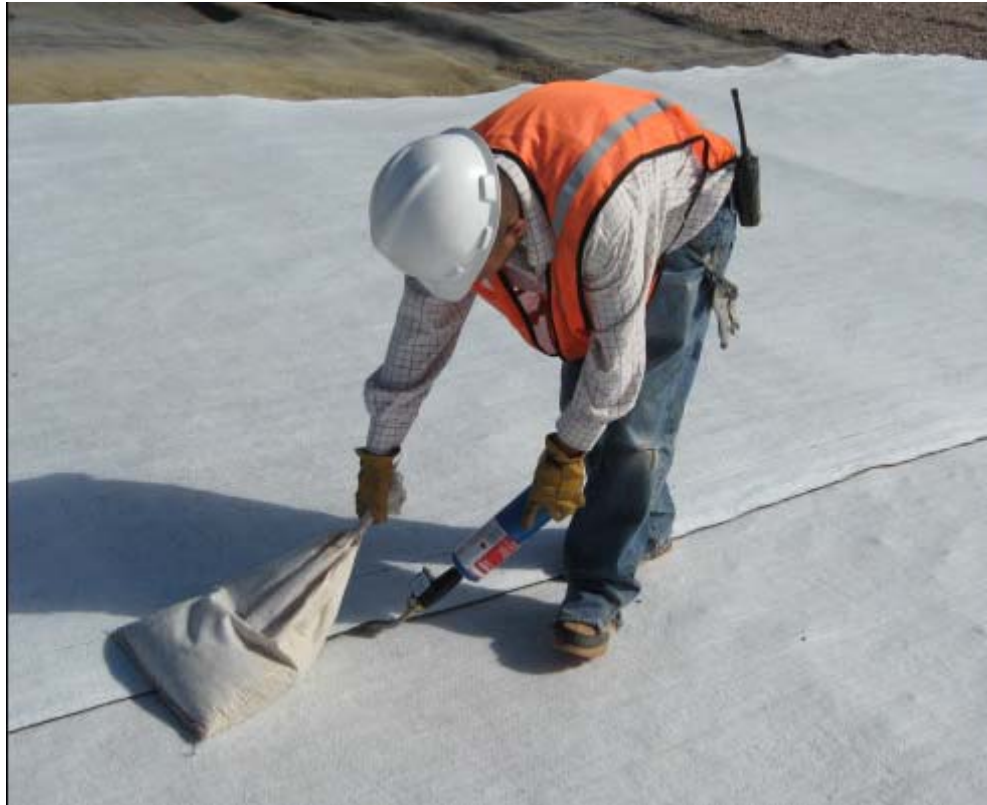
Figure 1. Installer heat-tacking GCL edge seam with a 150 mm overlap.

Thiel (2008) recently proposed a novel field approach to addressing the concern regarding separation of GCL panels forming part of a composite liner for a large (60ha) heap leach pad at the Carlota Mine in Arizona, USA (latitude 33°N). The pad was constructed in an alluvium deposit consisting primarily of eroded Pinal Schist, Schultz Granite and Dacite materials. The subgrade upon which the liner was placed was moderately to highly weathered bedrock in the form of a gravelly, silty sand that breaks down during mechanical compaction and surface rolling. The material is of low plasticity and is subject to rapid drying in the local climate. The moisture content (MC) during compaction was 10% to 12% but due to the arid climate, the moisture content dropped off with depth. Depending on the time installed (i.e. proximity to rain events) and the location within the leach pad the subgrade moisture content may have varied between 5% and 20% when the GCL was placed. In some areas a double-nonwoven, needle-punched GCL was used because of its enhanced shear strength, even though this particular GCL experienced the greatest shrinkage in laboratory tests and in field cases where loss of overlap had been observed. In other areas where shear strength was not as critical, a woven-nonwoven, needle-punched GCL (which was slightly less expensive) was used. Each 150 mm GCL panel overlap was heat-tacked with a quick application of a flame torch followed immediately by light pressure (Figure 1). The geomembrane was then placed over the GCL (same day) but it was often 60 days or more before cover soil was placed. To verify that the GCL overlaps had remained intact, the CQA firm cut holes through the geomembrane to exhume the GCL in areas that had been unballasted for more than 60 days. Both the double-nonwoven and the woven-nonwoven GCL products were evaluated. The exhumations were performed at mid-slope in six separate areas of the project

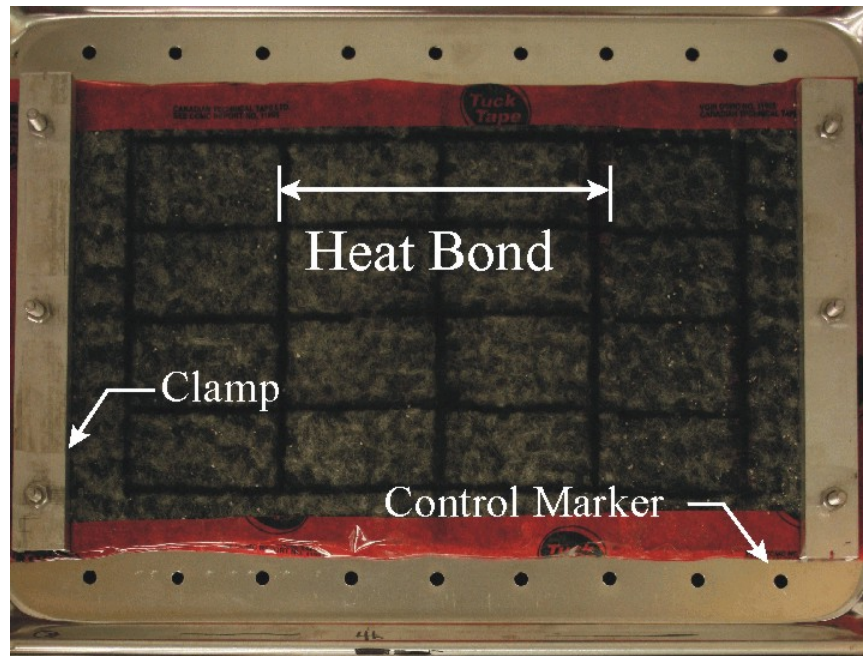
Figure 2. Pan setup immediately before commencement of testing.

Following the methodology of Thiel et al. (2006), a 25 mm border was drawn on all sides of the GCL specimen to enable hand measurements of the dimensions of the sample whilst minimizing edge effects; this resulted in an area of interest of 175 mm by 300 mm. Measurement points were also drawn at quarter points across the sample. All final calculations were based on the distance between border lines, hereafter termed the gauge distance. Moisture barrier tape was used to prevent bentonite loss from the cut edges. Figure 2 shows a pan prior to testing.

Digital photographs were taken with a 10 megapixel digital SLR camera mounted to a specially constructed frame. Photographs were taken twice per cycle: once immediately following the drying phase (but before applying water) and at the end of the hydration period (immediately before the drying phase). To eliminate the effects of small, unavoidable camera or pan movement, the image was calibrated by means of control markers located on the sides of the pan (see Figure 2).

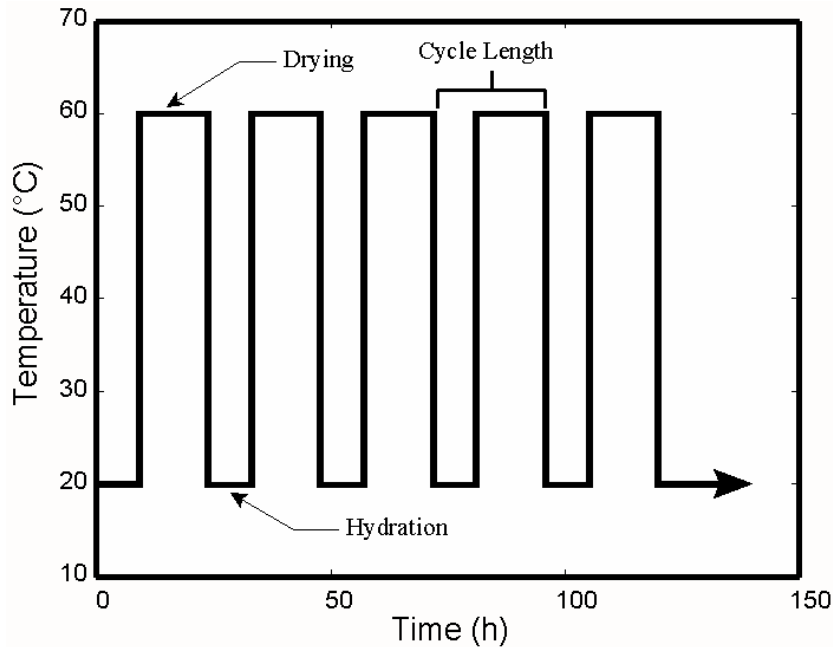
Figure 3. Hydration and Drying Cycles

At the conclusion of the heating cycle, the specimen was removed from the oven and returned to the 20°C room. Measurements were taken at key locations on the sample; the sample subsequently underwent the wetting process as described above. Handling of the sample required approximately 1 hour, resulting in a 24-hour total cycle length. The testing process was designed such that this wetting/drying cycle was repeated until such time as shrinkage has ceased. The cycle is illustrated in Figure 3.

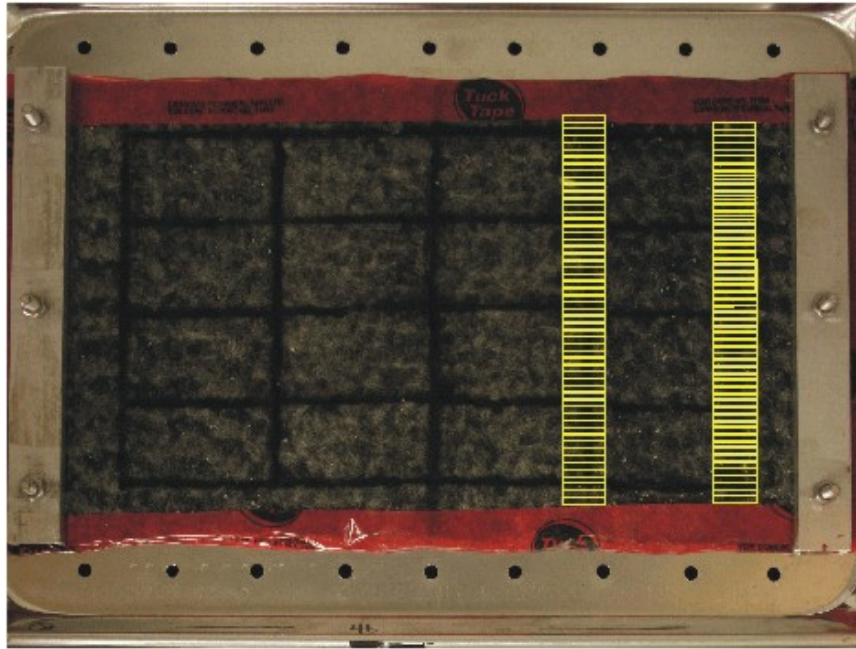
Figure 4. Virtual GeoPIV “patches” used to track seam movement

Digital image correlation is an image processing technique which enables deformations to be tracked by comparing a series of digital images; in this case, images of the GCL sample at the end of each part of the shrinkage and swelling cycles. Using the GeoPIV code developed by White et. al. (2003), this technique was used to track the cyclic strains of the GCL sample at many locations. Upon completion of testing, fifty-one virtual “patches” measuring 128 x 128 pixels were created along the length of the sample, coincident with the border lines. Using the unique color distribution of each patch (known as the patch “texture”), these locations were then tracked in each subsequent image. By comparing the movement of each patch to that of the one located directly across from it, the cross-sample strain was obtained. This method was also used to approximate the movement of the seam, with patches located at the top edge of the sample and the visible seam edge; this is shown in Figure 4.

Due to the clamping and the arrangement of the samples in the pan, a tensile force was induced perpendicular to the seam as the specimen began to shrink. The tensile strain that developed in the GCL adjacent to the seam, which generated the tensile force on the seam, increased as the number of wet-dry cycles increased. To quantify this strain, the positions of the upper (visible) seam edge and a relatively stationary region near the clamp were compared and expressed as percent strain. These measurement locations are shown above in Figure 4.

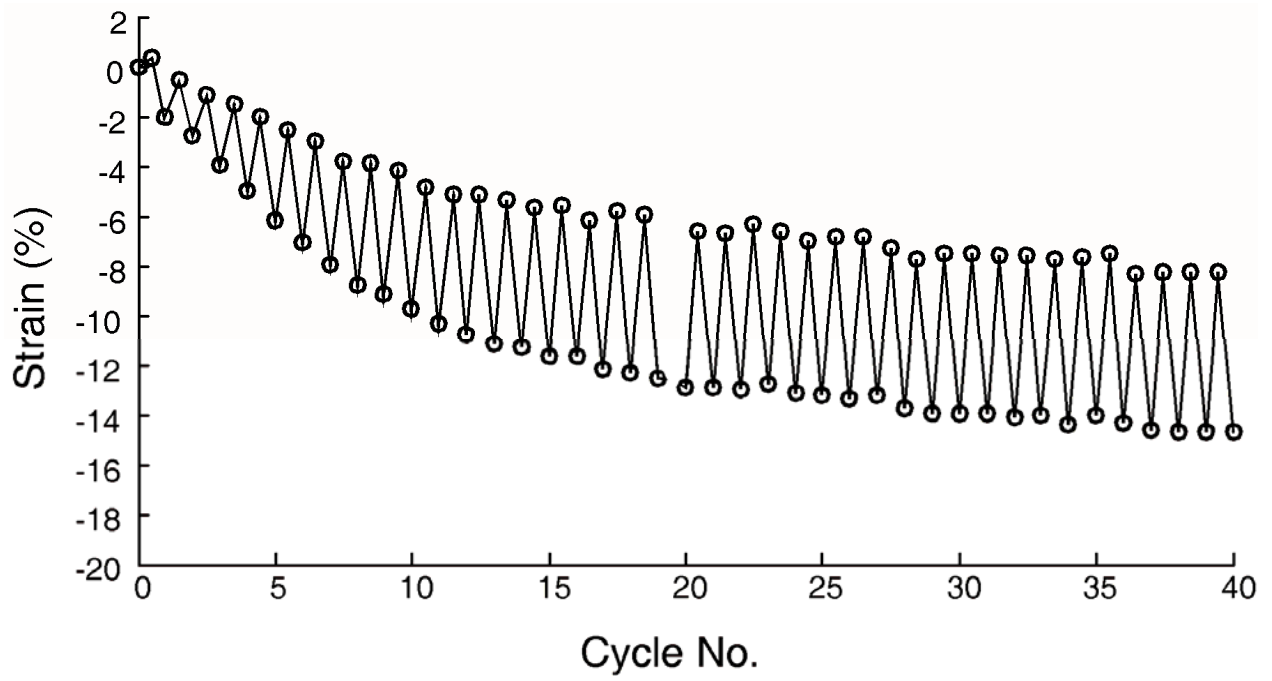
Figure 5. Shrinkage and swelling strain.

The wet-dry cycling of the testing caused the GCL to shrink across the sample (corresponding to the MD off the roll). As the number of cycles increased, this shrinkage became more pronounced. Figure 5 shows the strain across the middle of the seam versus the number of cycles. As the sample is wetted at the beginning of each cycle the GCL swells, resulting in a positive change in strain. Following drying, however, the sample shrinks, which corresponds to a negative strain. Although each subsequent wetting phase produces a relative positive strain, it is not sufficient to fully counteract the effect of shrinkage; the overall trend is a negative strain. This behavior is consistent with similar studies previously performed (Thiel et. al. 2006, Bostwick et. al. 2007, Bostwick et. al. 2008).

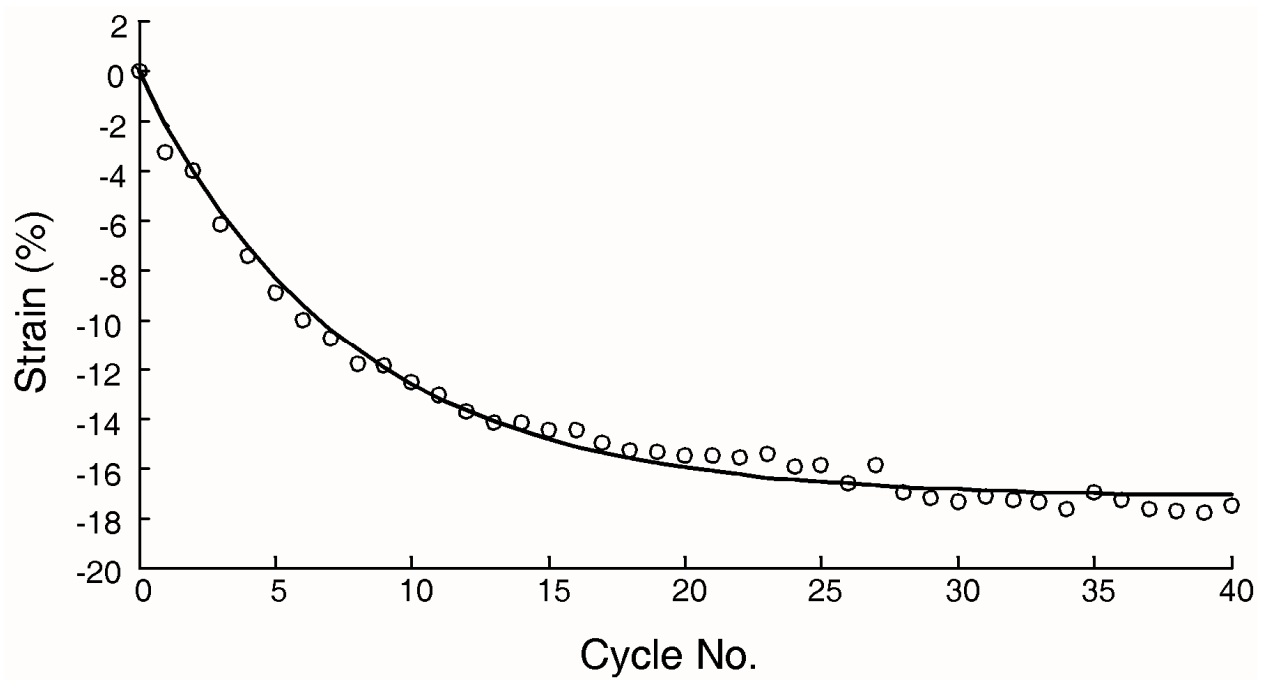
Figure 6. Maximum sample strain.

In previous restrained GCL shrinkage tests, the clamping at each end of the sample caused shrinkage near the middle of the sample, with relatively little shrinkage occurring near the clamps. In this test however, the presence of the seam at the midpoint of the sample restricted strain at that location. The maximum shrinkage strain was observed near the edge of the lower seam – roughly 150mm from the left clamp. This is depicted in Figure 6.

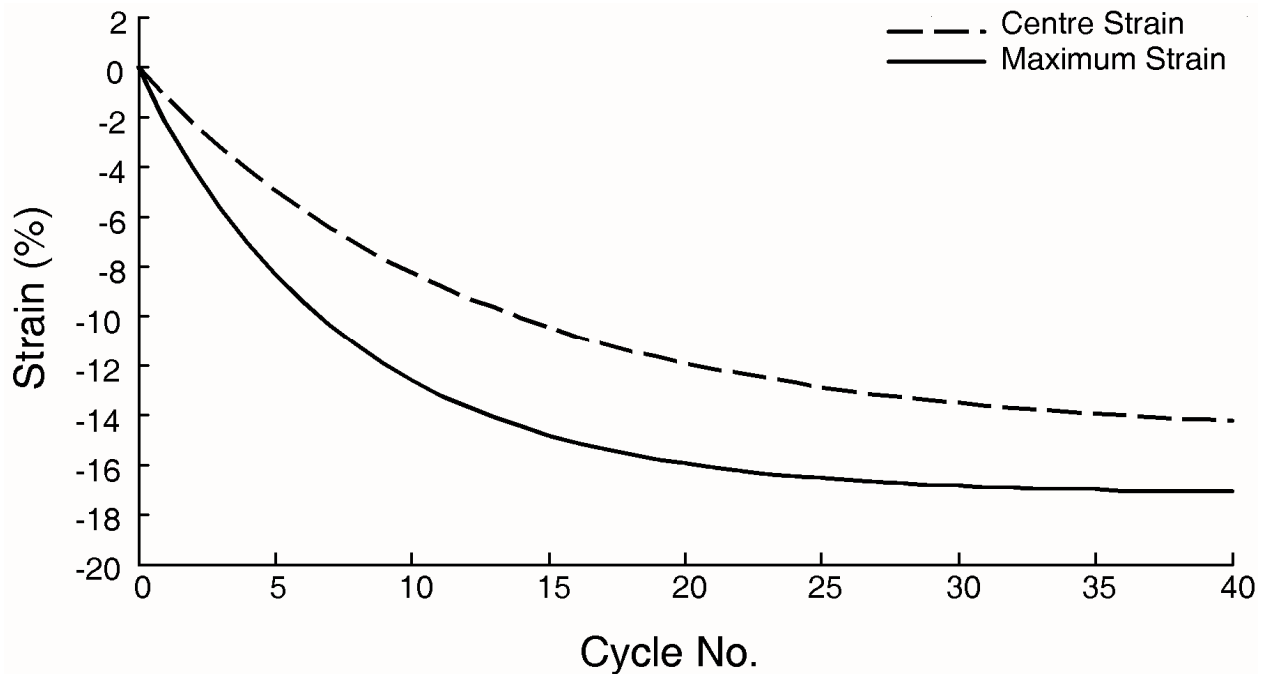
Figure 7. Comparison of maximum shrinkage strain versus that at centre of seam

As summarized in Table 2, the shrinkage strain at the centre of the sample was -14.2%, while the shrinkage at the centre seam was found to be 84% of the maximum strain observed on the sample.

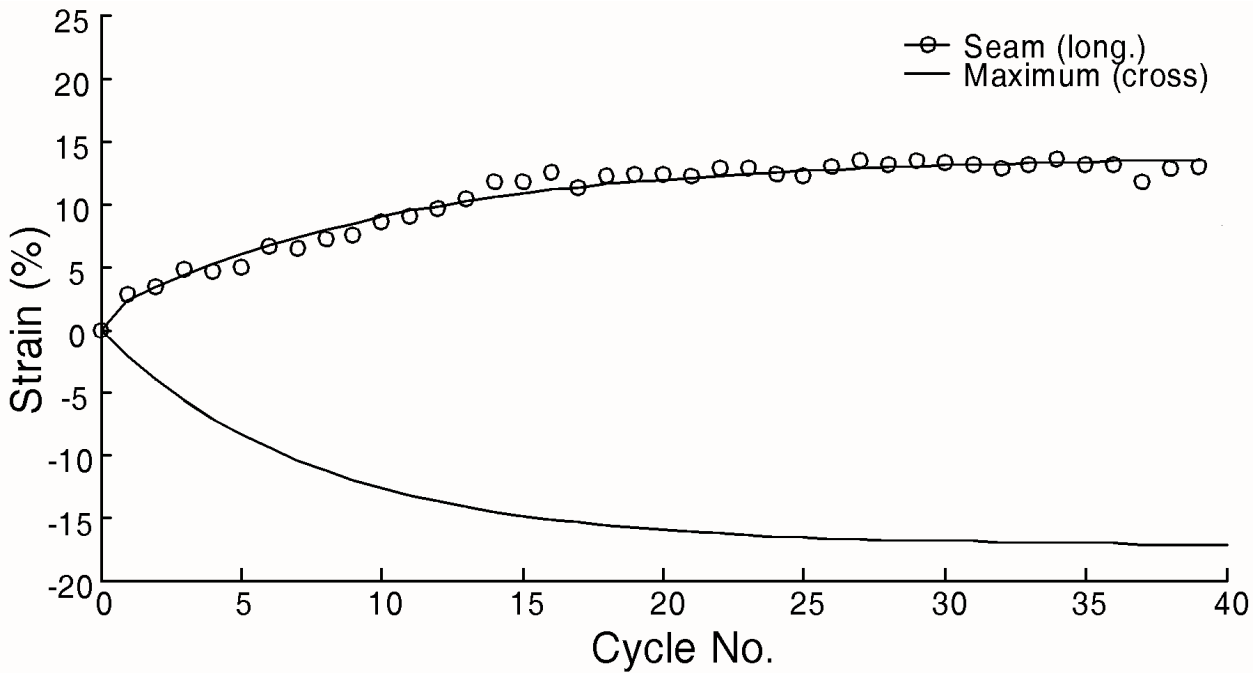
Figure 8. Seam separation as compared to absolute maximum shrinkage.

As shown in Figure 8, the tensile strain in the GCL adjacent to the seam (which occurs in the cross-machine direction) exhibits similar behavior to the shrinkage between the restrained ends (which represent points of no movement in the GCL such as would, for example, occur at the mid point of each panel in a symmetric panel layout). The degree of shrinkage across the sample and the tensile strain in the GCL adjacent to the GCL seam both increased with the number of cycles.

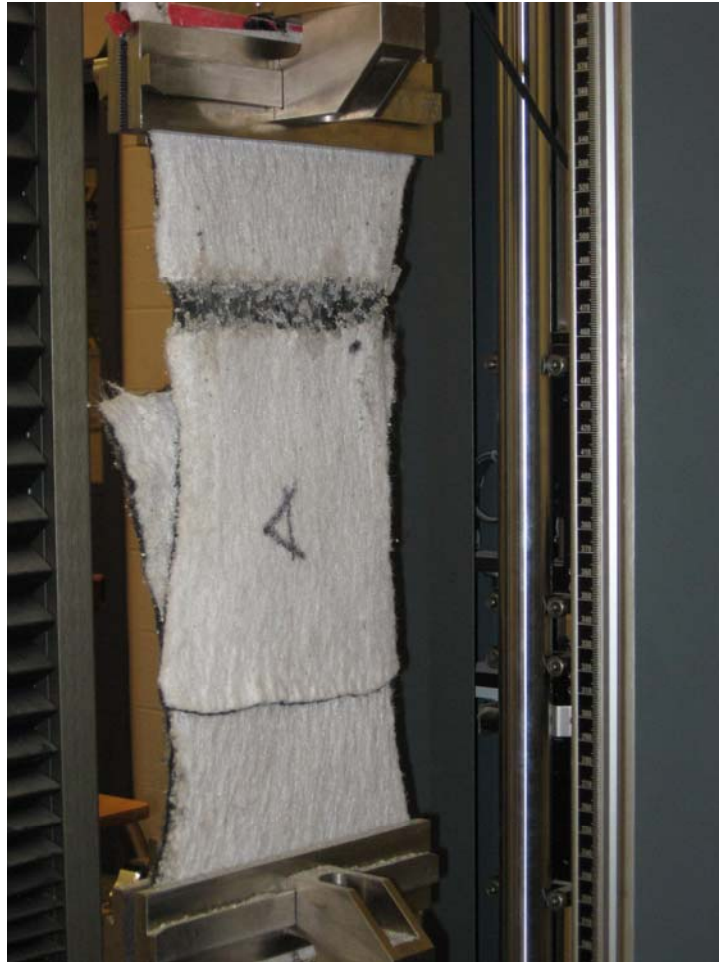
Figure 9. Tensile failure of specimen by pre-engineered groove.

Following the conclusion of the test at 40 cycles, the sample was removed from the pan and the remaining heat-tack strength was tested as per ASTM D4595. The results (summarized in Table 3) show that the strength of the bond following the wet-dry cycling was greater than the seam strength obtained in two tests on virgin seams. Given the method adopted for forming the seam, some variability in seam strength can be expected and it is not implied that shrinkage necessarily strengthened the seam – but it certainly did not appear to have decreased the seam strength in this case. In the tensile test, the sample failed at the pre-engineered groove at the roll edge (as shown in Figure 9), indicating that the heat-tack had in fact held; hence, it may be inferred that the seam strength was greater than the value indicated in Table 3. In these cases the capacity of the heat-tacking to prevent separation will be controlled by the GCL strength at the groove.
